Inspection Photos

I00090053+07232

Location 10 KM E SUPERIOR Stucture Name: none

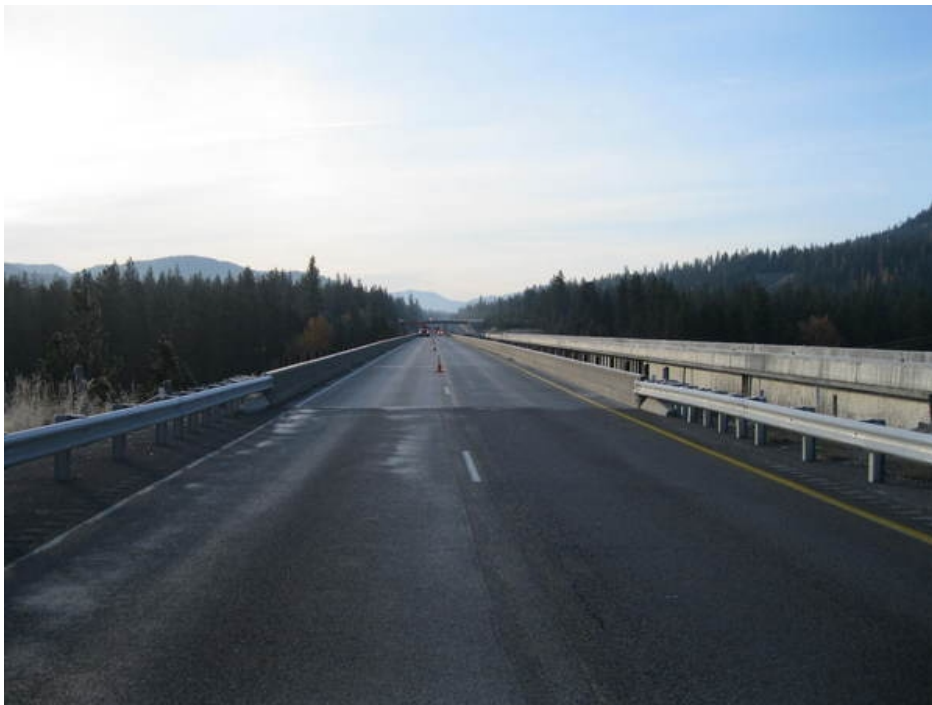
AOL
Notes

Looking AOL

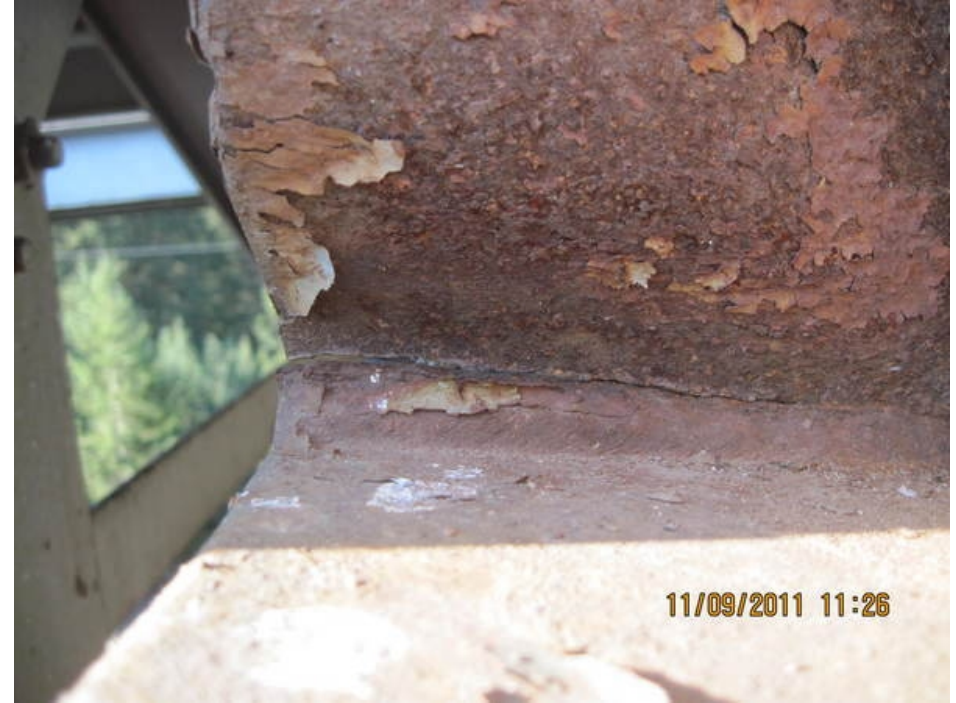
Girder end b6 left

Bent 6 span 5 left girder end same area as last photo. this area was only bent in 2009 inspection.

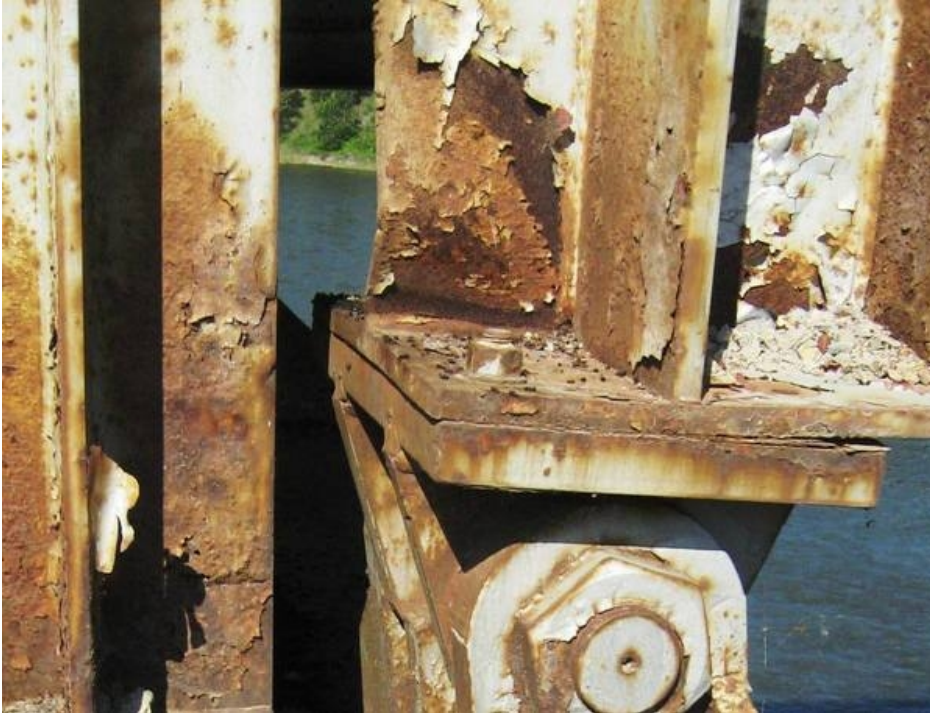
2009 photo b6 girder

This a photo of bent6 span5 left girder from 2009 note amount of gap between bearing and bottom of girder compaired to 2011 inspection.
Also note web near bottom flange at end of girder is only bent 2009 , broken 2011.

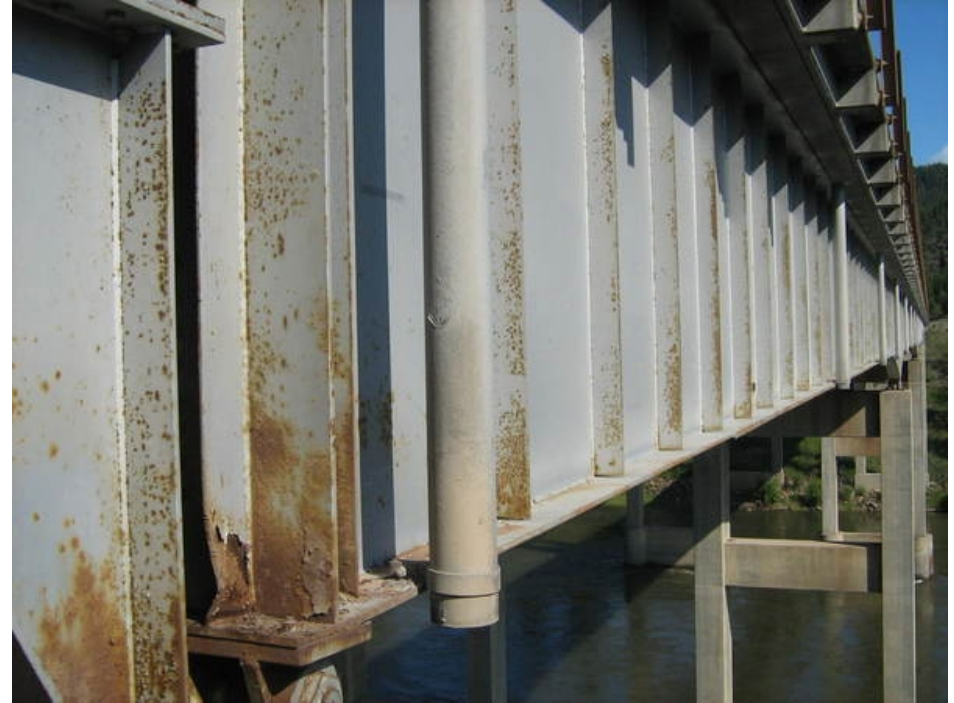
2009 b6 left girder

Another view of bent 6 span 5 end left girder from 2009.

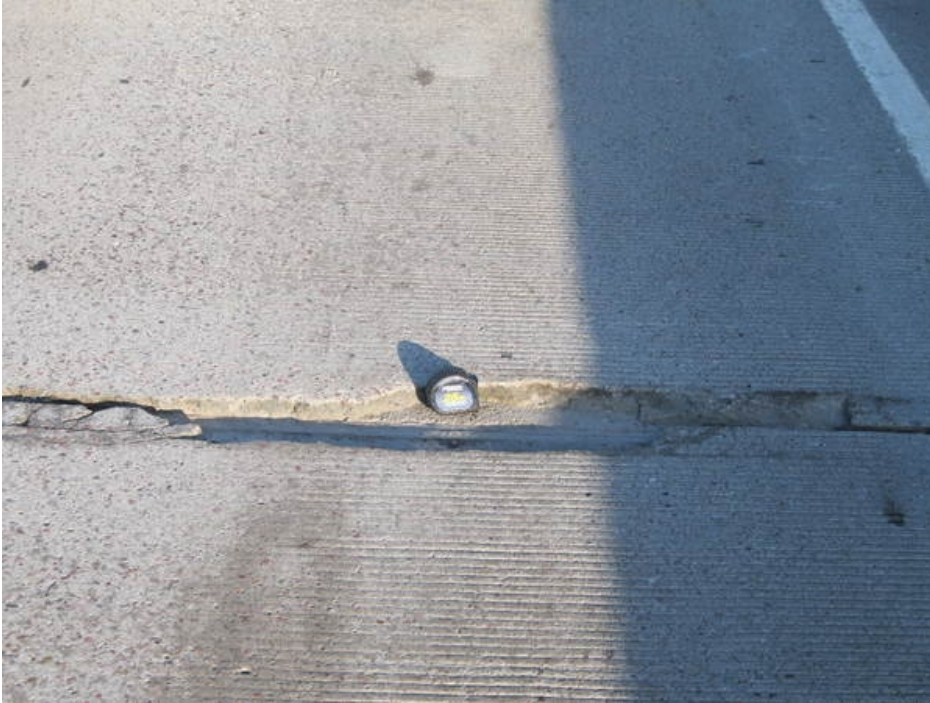
Joint bent 5

Spalling around joint at bent 5.

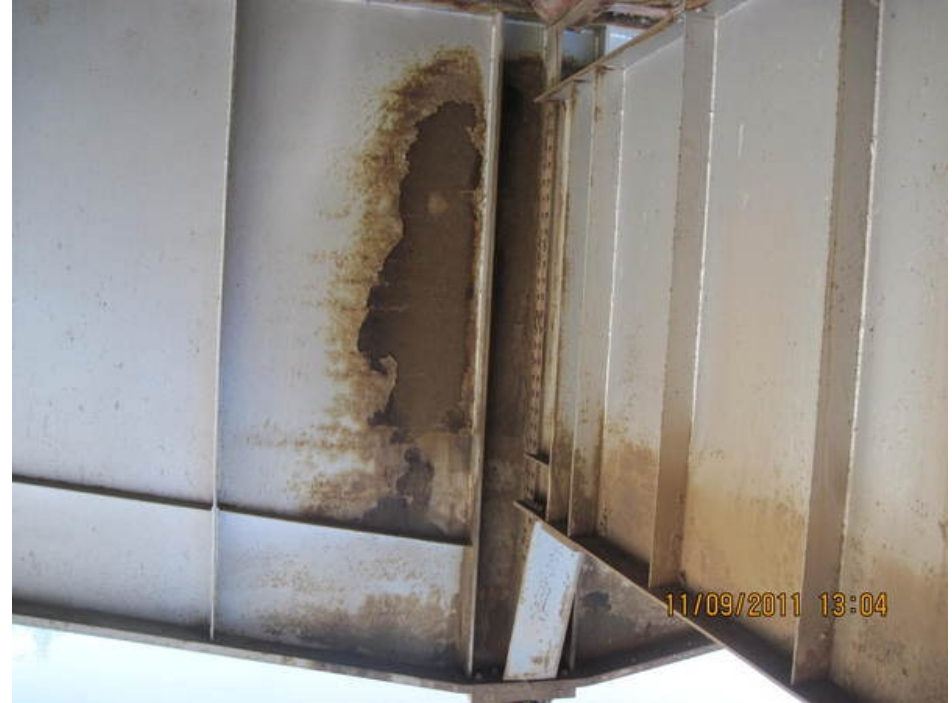
Girder B4 Left

Girder at bent 4 left span 3 side web. Paint loss rust,no section loss yet. Typical at bents.

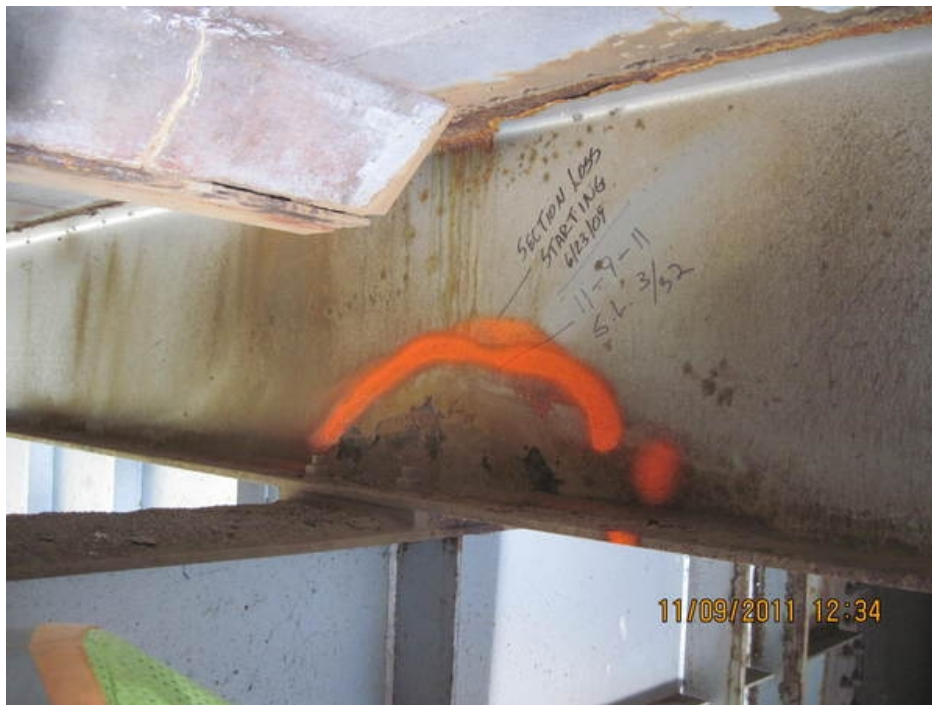
Stringer B4

Stringer bent 4 number 1 left. 3/32" section loss in web. 2009 just a start of section loss.

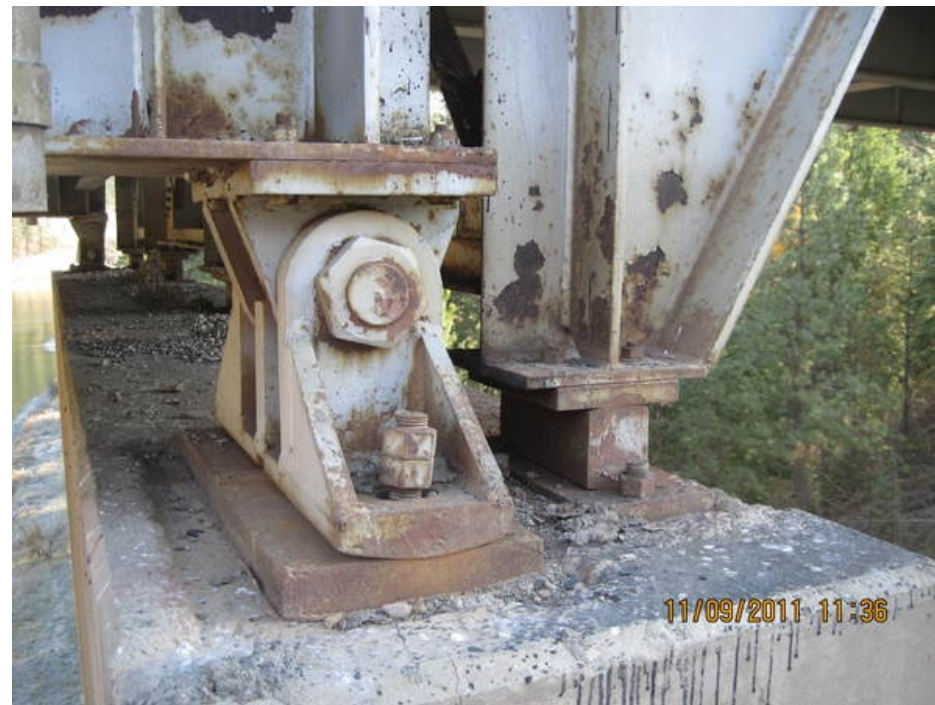
Bearing B6 RT

Bearings bent 6 right, spans 5 and 6.

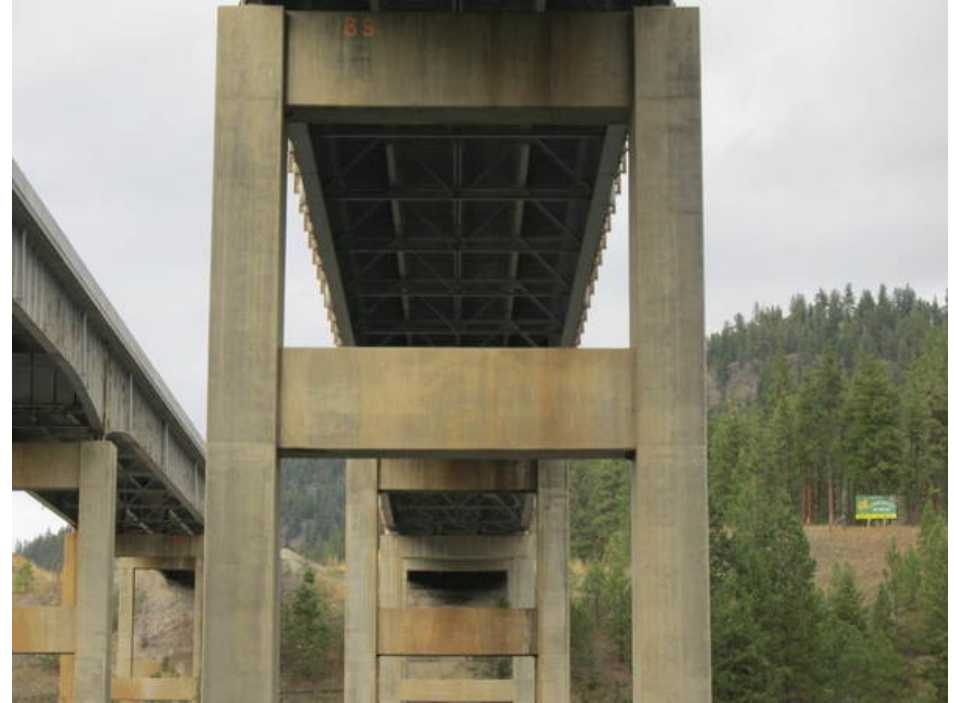
Under deck at bent 6 looking BOL.

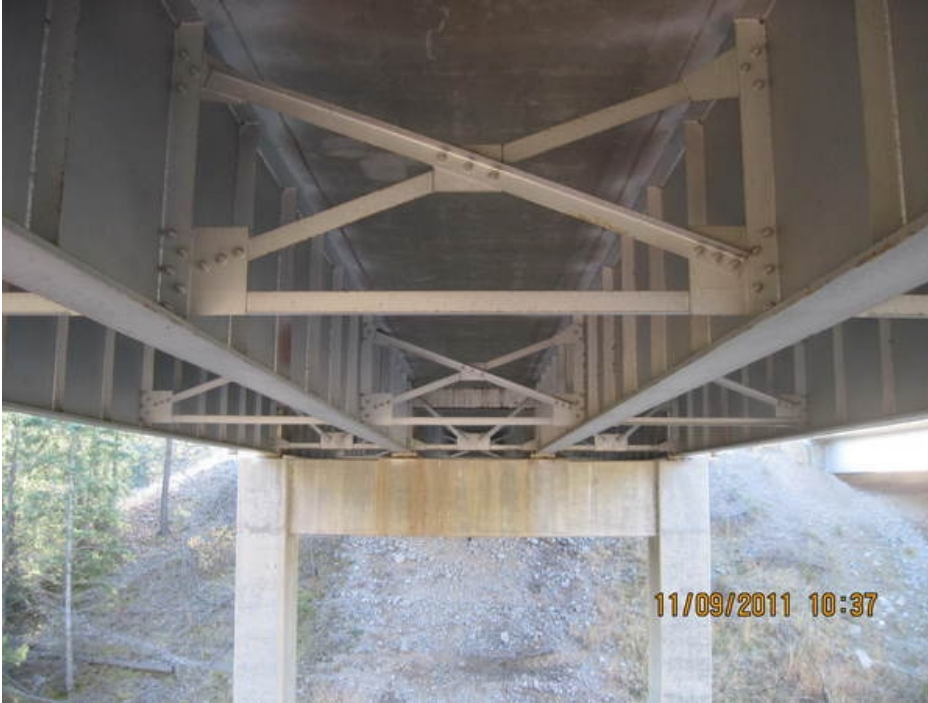
Under deck span6

Under deck span 6 looking AOL.

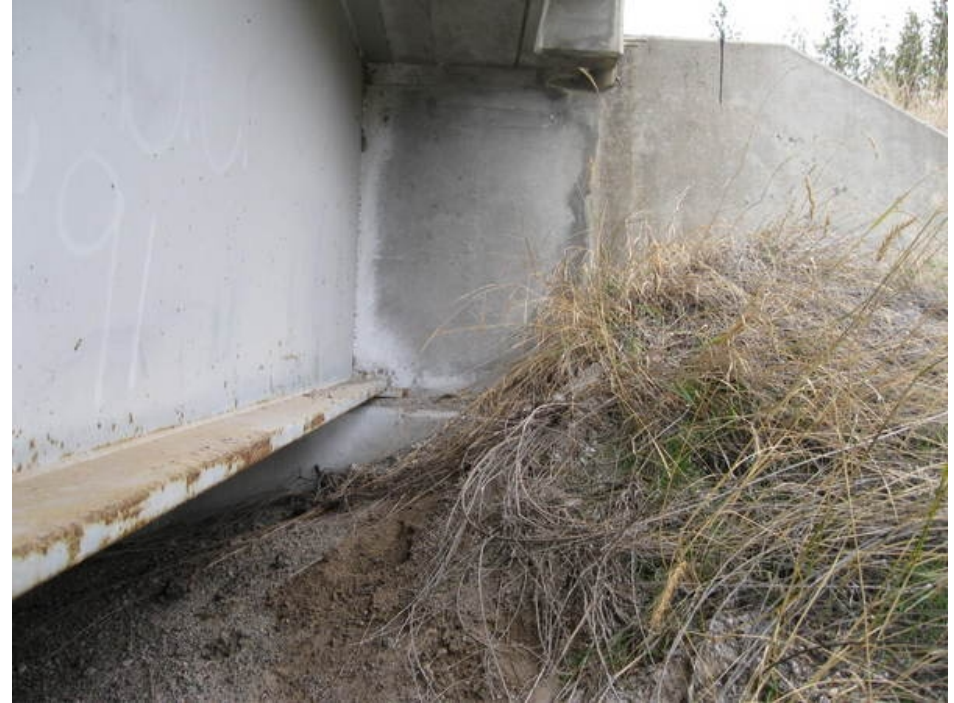
Abutment cap B1

Abutment at bent 1, left, cap looking BOL. Material on cap. Typical all 4 corners of bridge.

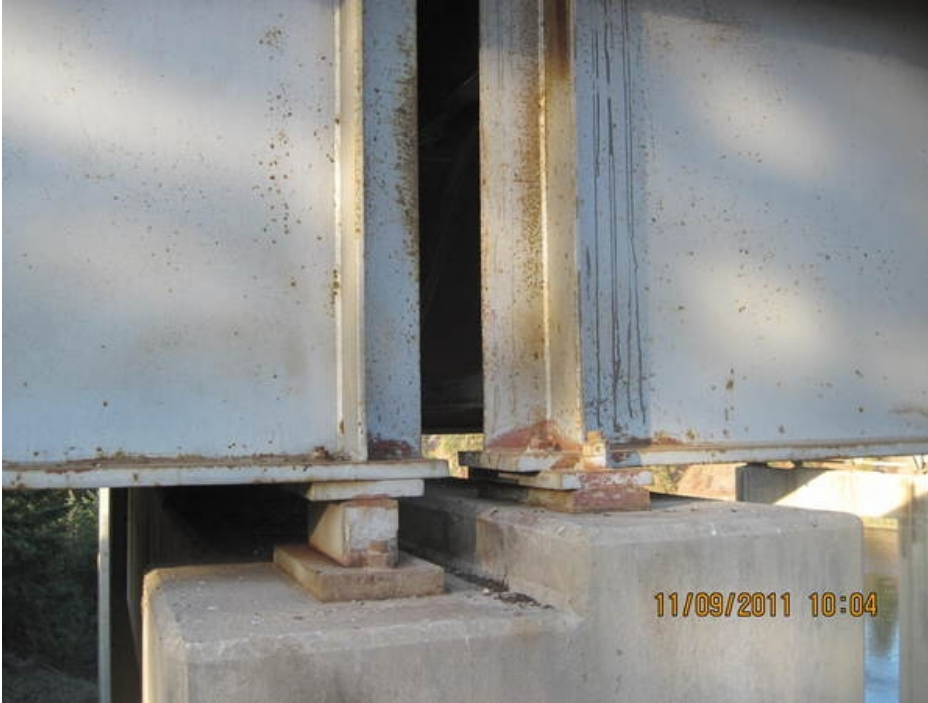
Bearings B7 Lt

Bearings bent 7 left side. Span 6 and 7. Typical of bearings at bent 7.

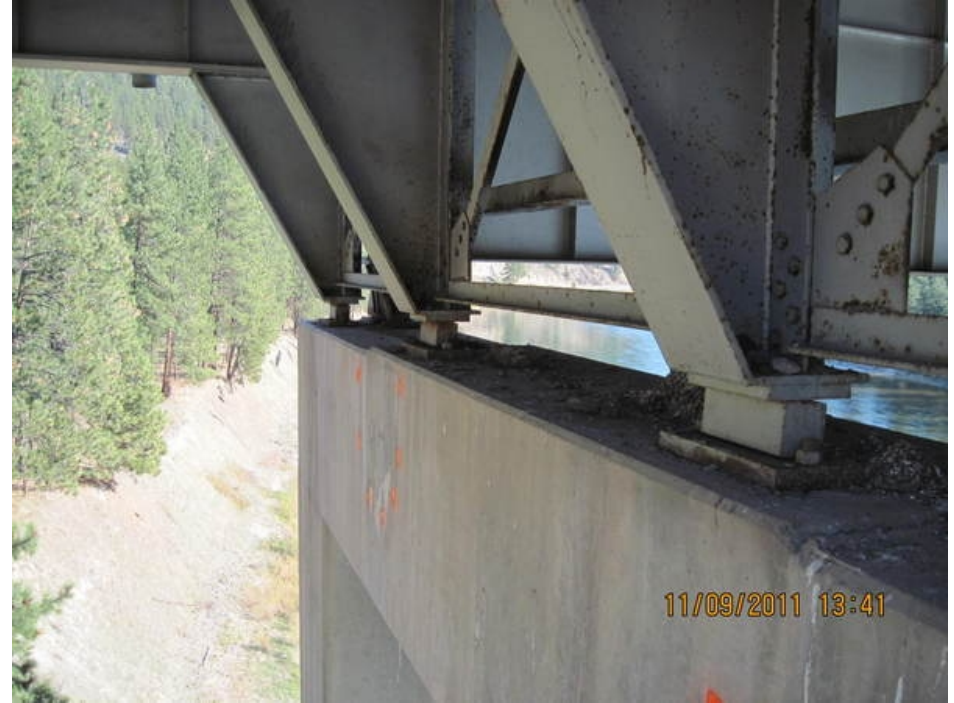
Bent 3 cap span 2 side note areas of delamination.
